Holistic behaviour of concrete buildings in fire.

Professor Colin Bailey
Manchester Centre for Civil and Construction Engineering
PO Box 88
Manchester
M60 1QD
UK

This paper was originally published in the Proceedings of the Institution of Civil Engineers, Structures and Buildings 152, August 2002, Issue 3, pp 199-212. It is republished here with kind permission of Thomas Telford Limited.

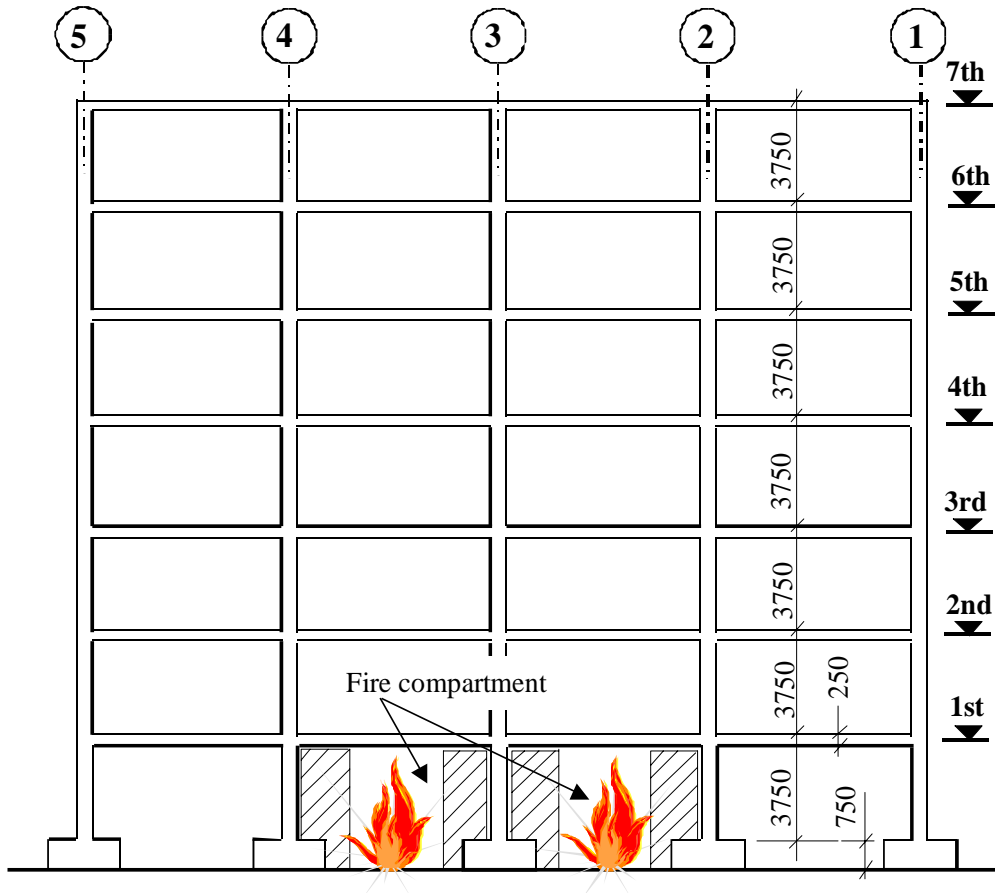
Figure 2 Cross-section through the building showing location of fire test.

A fire compartment, with a floor area of 225m², was constructed between the ground and first floors (Figures 1 and 2). Due to the height of the footings, the overall height of the compartment from the laboratory floor to the underside of the first floor was 4.25m (Figure 2). The compartment walls were constructed using 140mm thick Topcrete blocks and lined, inside the compartment, with one skin of plasterboard. The laboratory floor was also lined with plasterboard. The blockwork was constructed such that a gap of 325mm was left between the top of the wall and underside of the slab. This gap was filled with a ceramic blanket which was fixed to the wall and shot fired to the underside of the slab (Figure 3). It was assumed that the design and construction of the compartment wall would contain the fire, whilst allowing vertical movement of the tested structure, without providing any support.

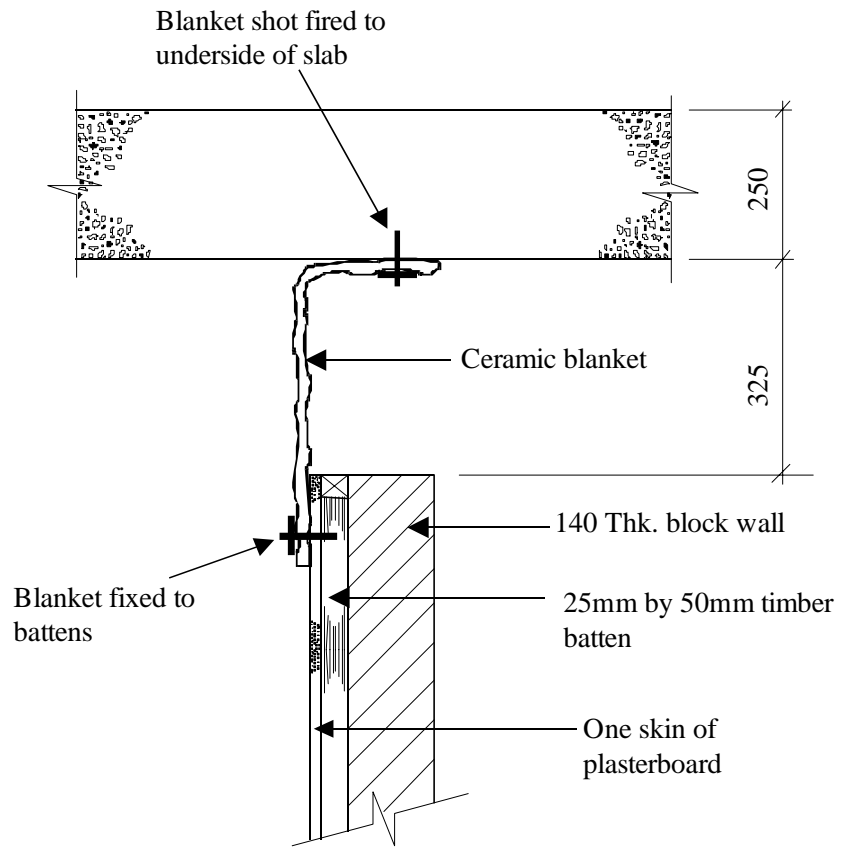
Figure 3 Detail showing fixing of ceramic blanket to first floor soffit and compartment wall.

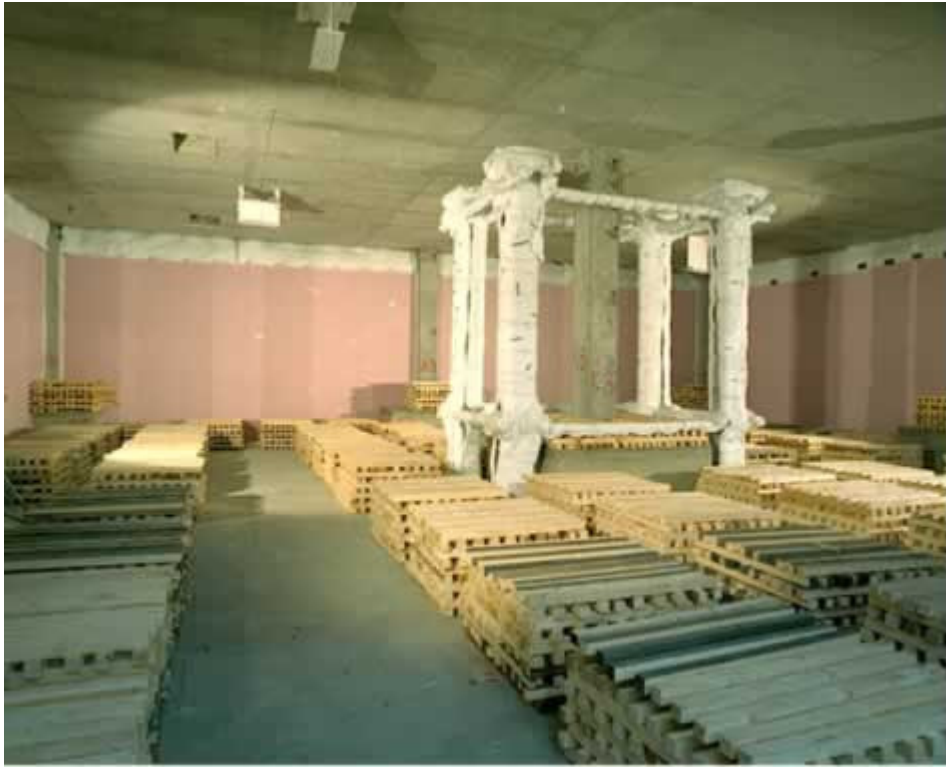
Figure 4 Fire compartment prior to ignition (looking from the openings along gridline D)

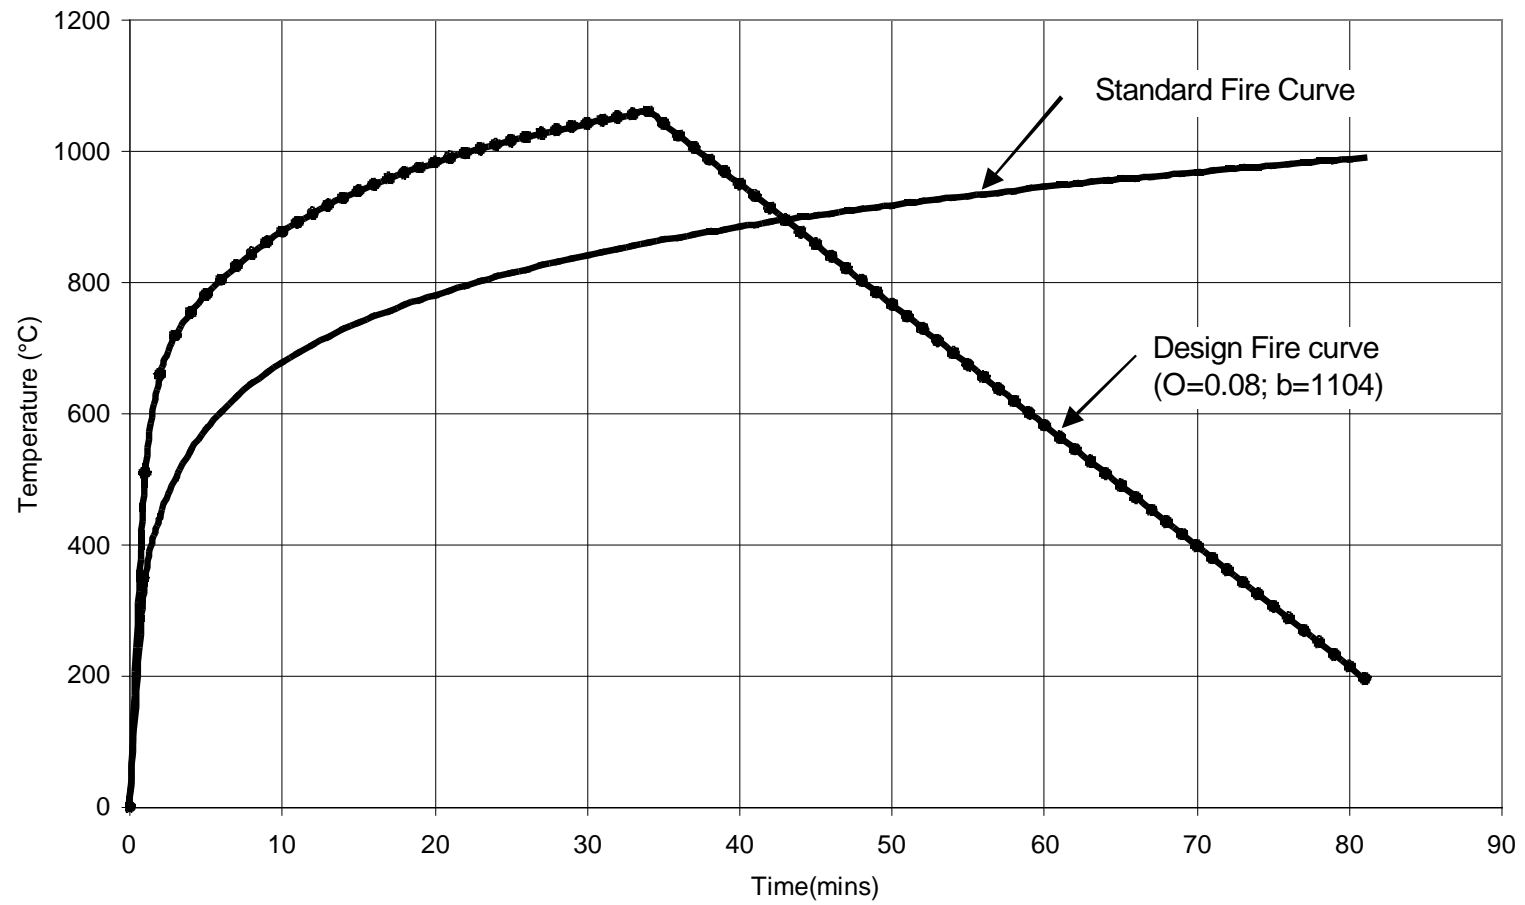
Figure 5 Design fire curve and standard fire curve.

It was decided that a realistic office fire would be obtained by providing ventilation to the compartment from full-height openings, creating a total area of 27.2m², along gridline D, which represents an opening that is equivalent to 12% of the compartment floor area. The fire consisted of timber cribs creating a fire load of 40kg/m² (720MJ/m²). The walls and floor of the compartment were lined with one skin of plasterboard. Figure 4 shows the fire compartment prior to ignition. The predicted time-temperature response from the Eurocode is shown in Figure 5.

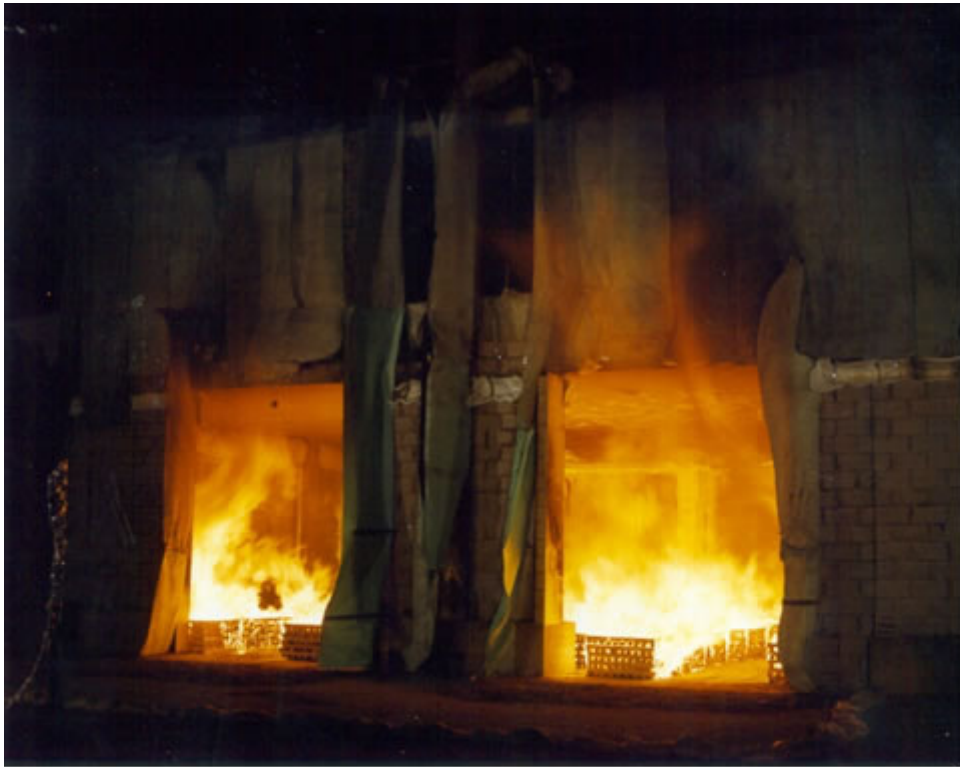
Figure 6 Fire test (Note the start of the spalling of the concrete soffit)

The test was conducted on the 26th September 2001 (Figure 6) and was witnessed by a number of experts from the UK and Europe. The instrumentation was checked before the fire test and shown to be working satisfactorily. Unfortunately, all the instruments malfunctioned approximately 18 minutes after ignition. The following explanation of the malfunction of the instruments is presented to aid future researchers carrying out similar large-scale tests and to

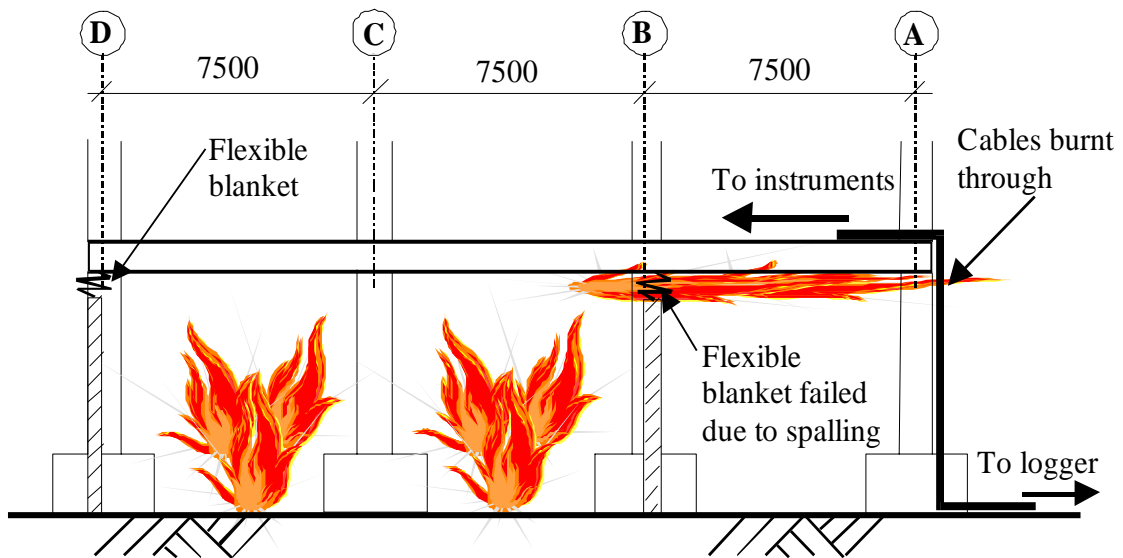
Figure 7: Diagram showing cause of instrumentation malfunction.

All the electrical cables to the instruments were run horizontally above the first floor to one point and then bound and dropped vertically at column A3 (Figure 1). These vertical cables were 7.5m from the fire compartment and were unprotected, since during the planning of the test they were considered to be a sufficient distance from the fire area. The compartment wall comprised blockwork, plasterboard and a ceramic blanket, as discussed in Section 4.0. The blanket was shot fired to the soffit of the first floor. However, when the concrete to the soffit began to spall, the fixings to the blanket failed. The fire escaped the compartment through the top 325mm opening and travelled horizontally 7.5m and burnt through the cables (Figure 7). The loss of the fixings in the soffit of the slab is shown in Figure 8. Where spalling did not occur the fixings remained in place, as shown in Figure 9. Any future design of compartment walls should consider the possibility of spalling of the concrete causing the loss of any fixings into the slab's soffit, which may lead to compartmentation failure.

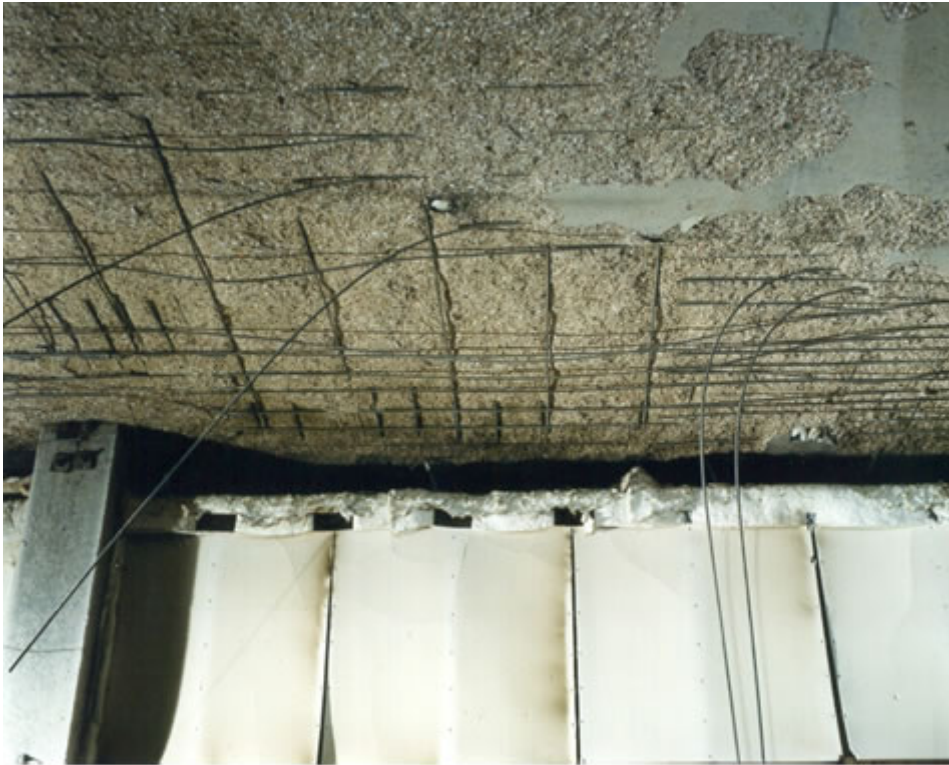
Figure 8 Picture looking at column C2 showing spalling to soffit of slab
(Note: Failure of blanket fixings into slab soffit)

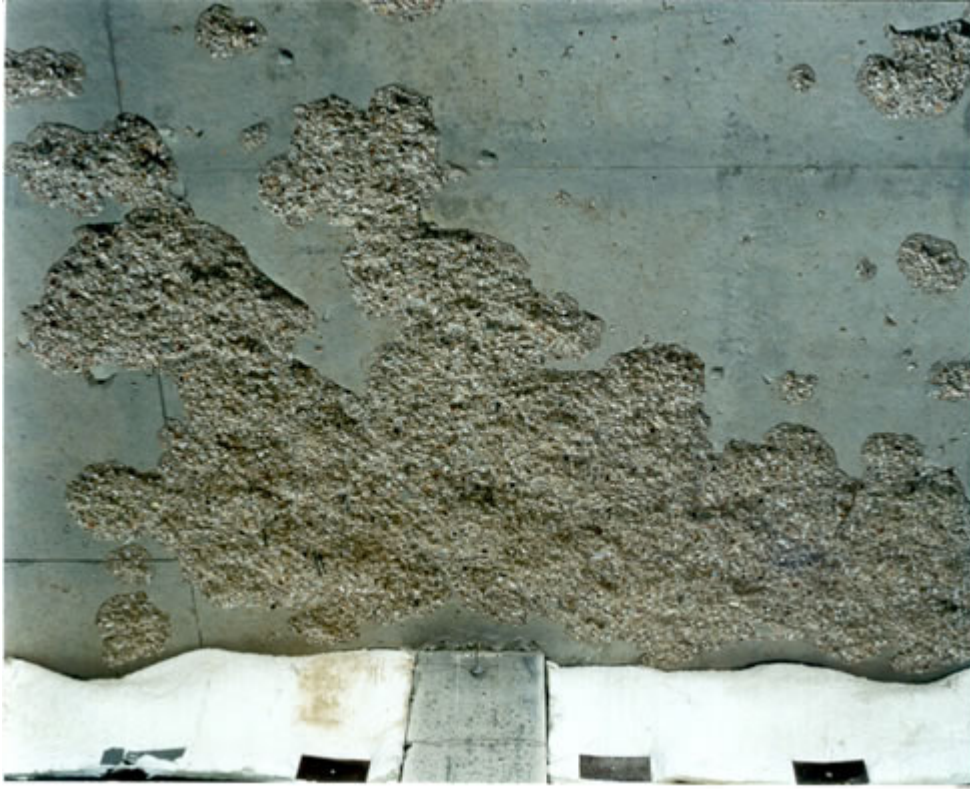
Figure 9 Picture looking at column D3
(Note: Fixings between blanket and soffit are intact due to limited spalling)

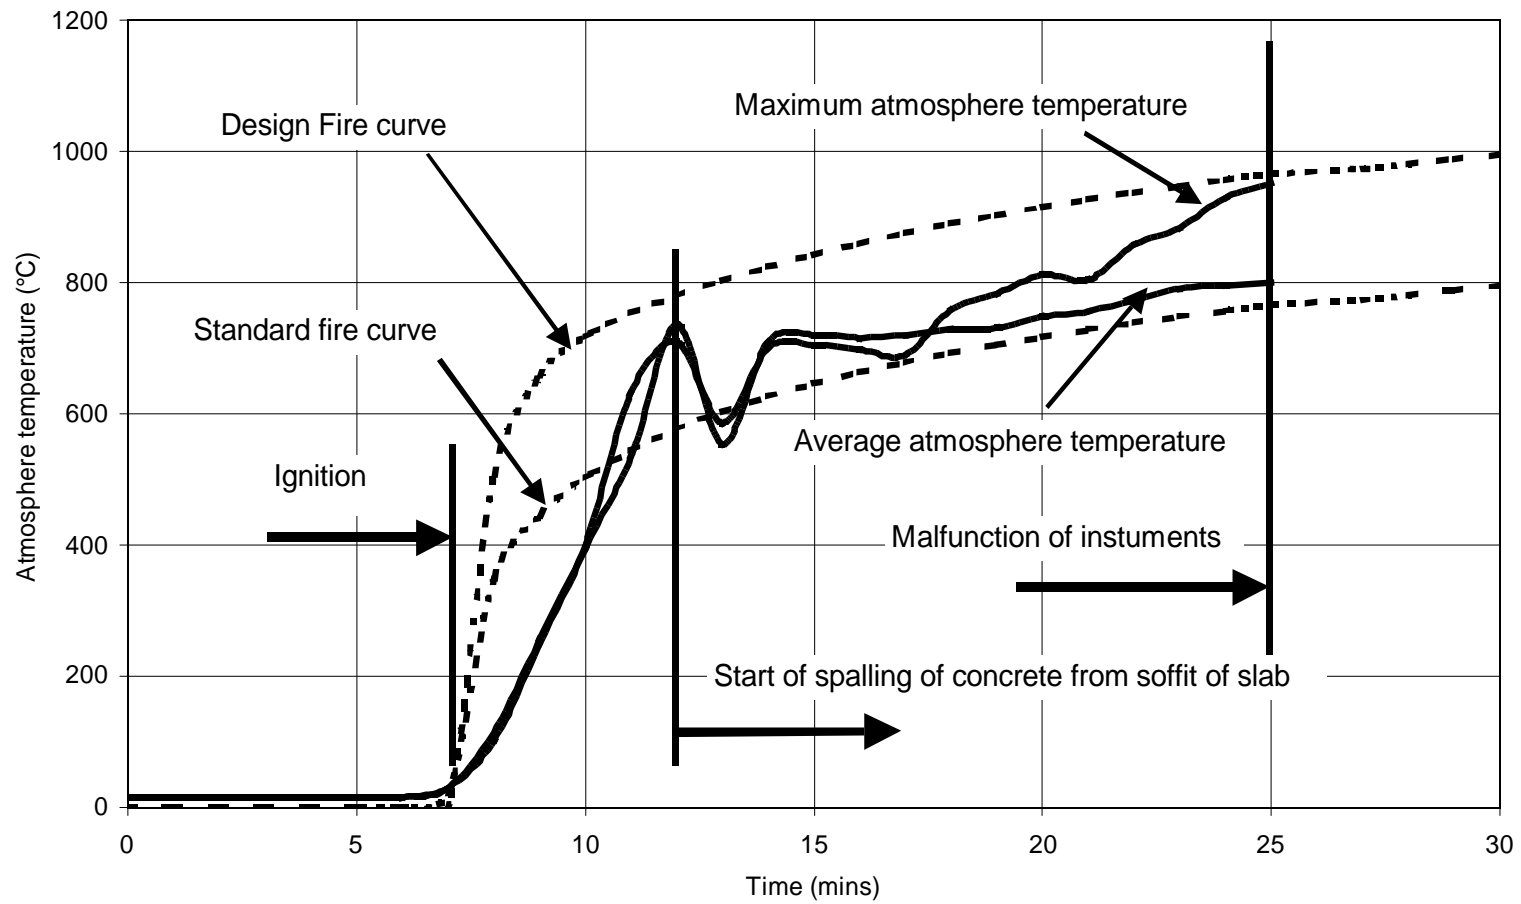
Figure 10 Recorded atmosphere temperatures throughout the compartment 300mm below the soffit of the slab.

The maximum atmosphere temperature, recorded during the test near to column B3, before malfunction of the instruments was 950°C. Figure 10 shows the recorded maximum atmosphere temperature and the average atmosphere temperature throughout the fire compartment. Considering Figure 10, it can be seen that the temperatures reduced considerably between 12 and 13 minutes after the start of logging (6 minutes after ignition). A video and time-lapse photos of the test show clearly that explosive spalling of the soffit of the floor slab began at this time. The spalling, which was extensive, reduced the severity of the fire throughout the test, which is an effect that has also been shown from other fire tests⁽²⁵⁾.

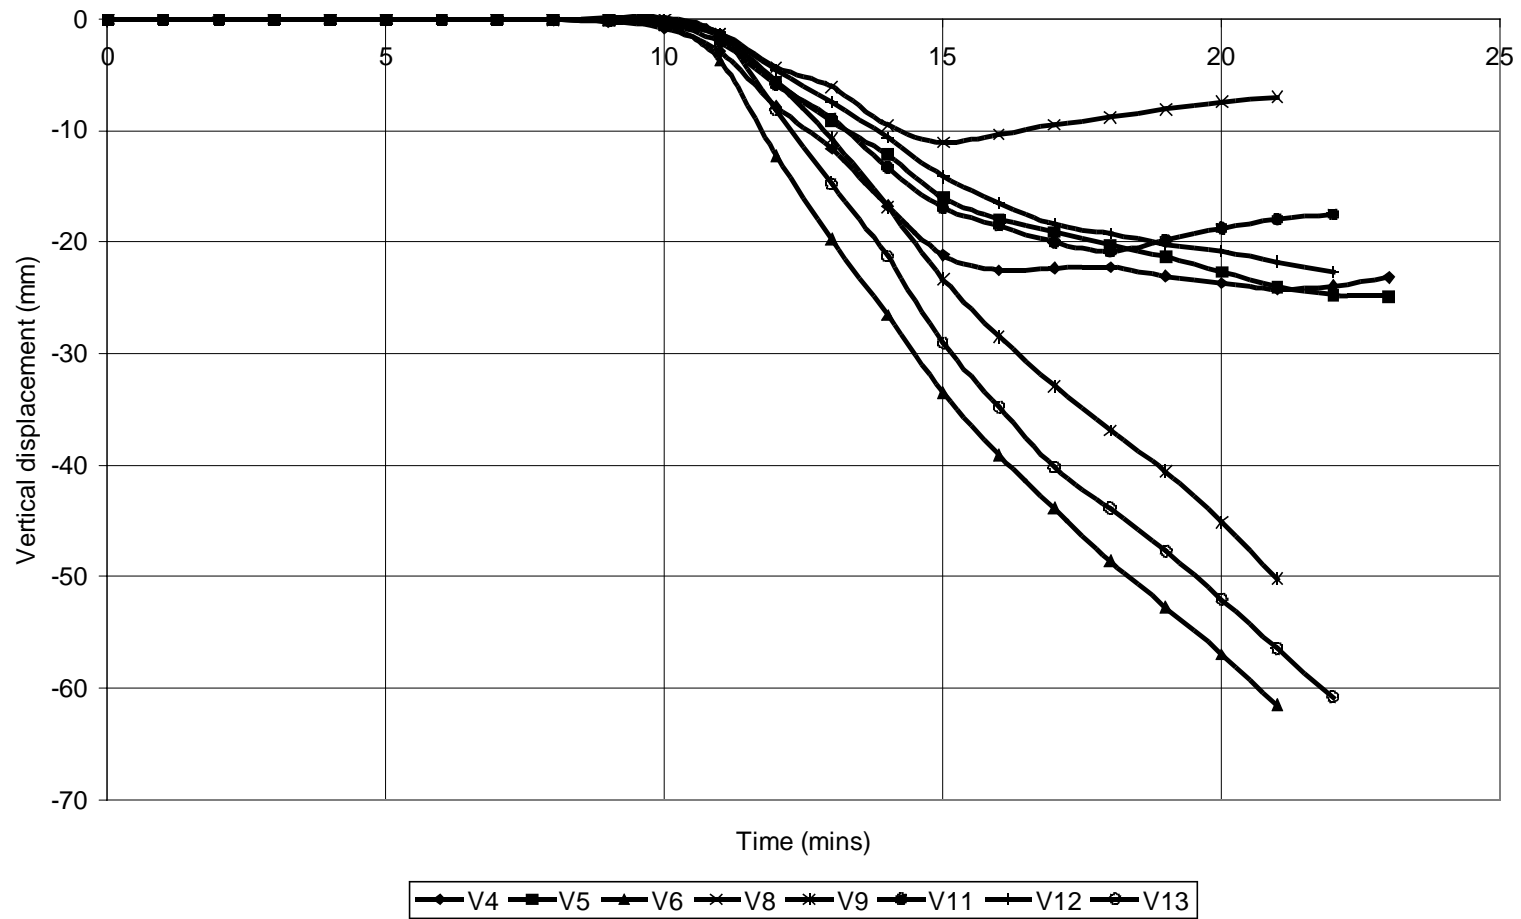
Figure 11 Measured displacements of the slab.
 (For location of measurements refer Figure 1)

The vertical displacements of the slab, at the locations shown in Figure 1, are shown in Figure 11, up to the time at which the instruments malfunctioned. It can be seen that the displacements near the centre of the building, at locations V4, V5, V8, V11 and V12 show a distinct plateau of constant displacement after 15 minutes. The displacements at locations V6, V9 and V13, towards the edge of the building, are much larger than the displacements near the centre and show no signs of a plateau.

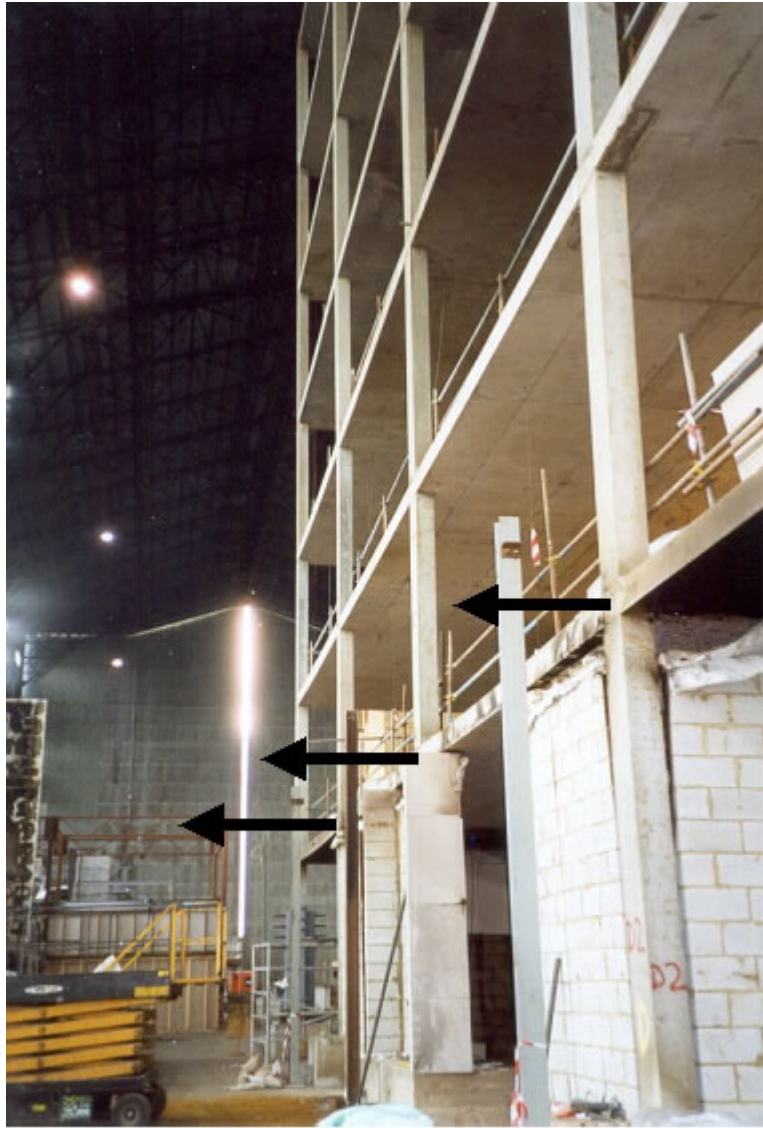
Figure 13 Picture showing lateral displacement of external columns.

The lateral movement of the heated slab in the test was significant, resulting in buckling of the steel cross-bracing and lateral displacement of the external columns. The buckling of the steel cross-bracing reduced the restraint slightly to the heated slab, whereas if concrete shear walls were used instead, the restraint to thermal expansion would have been greater, inducing higher compressive stresses in the slab and possibly increasing the severity of the spalling. The lateral movement of the external columns has been identified as the cause of previous failures⁽⁵⁾ of concrete structures, although the test discussed in this paper showed that the Cardington building was able to accommodate these movements. However, the designer should be aware of this behaviour and ensure that the columns can withstand the likely lateral displacement during the fire.

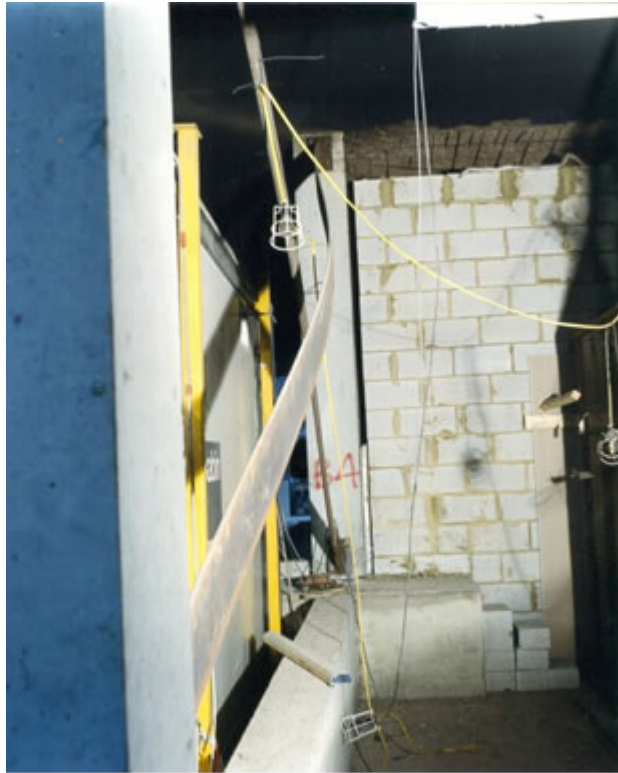
Figure 14 Buckling of bracing between columns B4 and B5 (similar buckling of bracing between columns C2 and C1 was also observed).

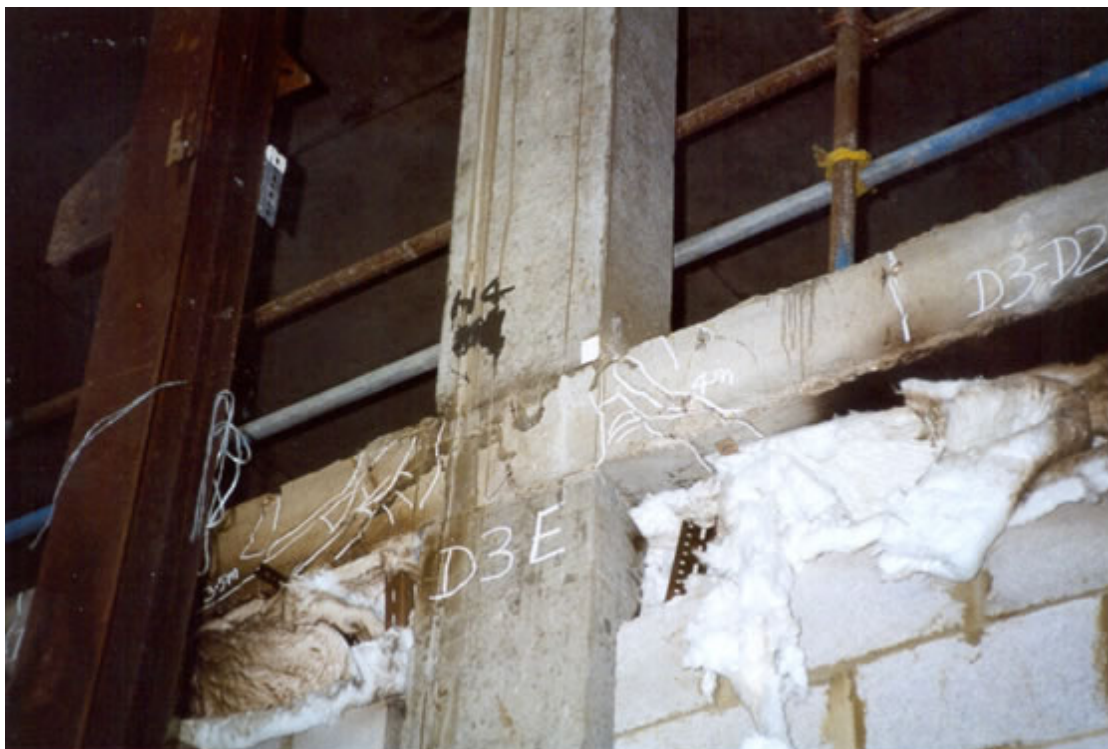
There was significant cracking around column D3 (Figure 15), which can be attributed to the hogging moment from the slab and the moment caused by the P- δ effect from the vertical load in the column and its lateral movement due to thermal expansion of the floor slab. The behaviour of the structure and recorded crack layout can be investigated more fully by the planned computer modelling of the test.

Figure 15 Cracking in the proximity of column D3

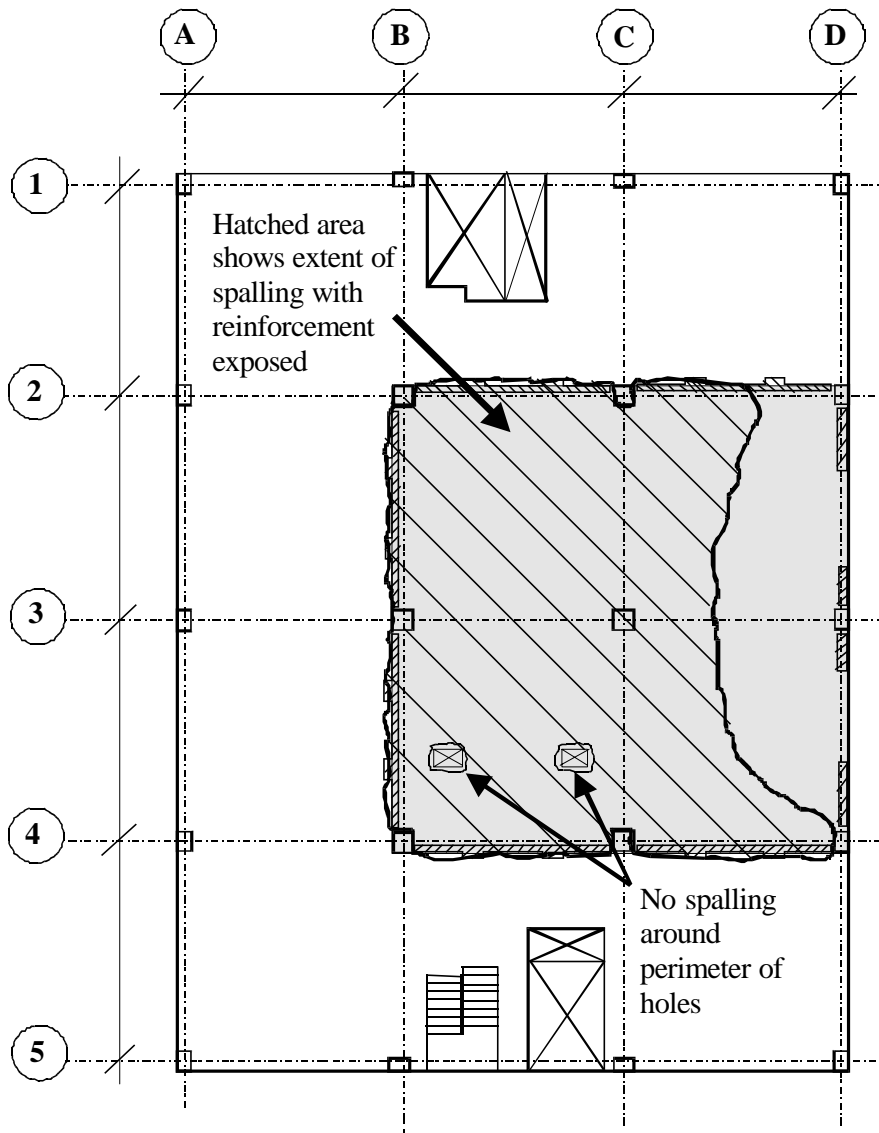
The extent of the spalling, which exposed the bottom reinforcement in the heated floor slab is shown in Figure 16. The pictures shown in Figures 17 and 18 also provide an appreciation of the extent of the spalling, and show reinforcement hanging from the soffit of the floor slab. A total of 10 reinforcement bars, 12mm diameter and 2.6m long were found on the compartment floor.

Examination of the area of the spalling, and the type of explosive nature of the spalling observed during the test, suggests that high compressive forces were induced in the slab due to restraint to thermal expansion. The behaviour of the spalling around the service holes (Figure 19) also suggests that spalling was primarily due to high compressive stresses, since where the compressive stresses are reduced along the edges of the hole no spalling occurred. Although these compressive stresses almost certainly led to the severity of the spalling, they

Figure 16 Extent of the spalling exposing bottom reinforcement in the slab.

The fire test showed that spalling to the soffit of the slab was extensive, exposing the bottom reinforcing bars. The spalling, which was explosive, was almost certainly due to the high in-plane compressive stresses in the slab, caused by the restraint to thermal expansion and the high pore water pressures⁽⁷⁾. Although the bottom bars were totally exposed to the fire, and thus the flexural capacity of the slab was drastically reduced, the slab remained stable and supported the applied static load by compressive membrane action. Considering this behaviour it could be argued that the codified approach of ignoring spalling is correct, since the slab continued to support the load. However, if the designer is ignoring the effects of spalling and relying on compressive membrane action then the mechanics of the behaviour should be understood and its limits defined. Compressive membrane action can only occur at small displacements (typically displacements less than half the thickness of the slab) and can occur in flat slabs, as shown from numerous previous tests^{(27),(28),(29)}. At large displacements tensile membrane action occurs, but its effects are small in flat slabs where the only vertical support is at the columns. For the slab to be supported by tensile membrane action, some vertical 'line' support between columns is required⁽³⁰⁾. This approach has been used successfully in the fire design of concrete composite floors in steel framed buildings^{(31),(32)}. However, it should be noted that for tensile membrane action, the reinforcing bars support the load and therefore need to retain their strength during a fire, which can only be achieved if sufficient concrete cover to the bars is maintained. During the test on the concrete building, the slab's vertical displacement was small and the static load was supported due to compressive membrane action. However, if the slab's vertical displacements were greater, due to perhaps a more severe fire, or a larger compartment area such that there was no cooler structure and thus lateral restraint surrounding the heated slab, then it is difficult to see how the slab could have supported the static load.

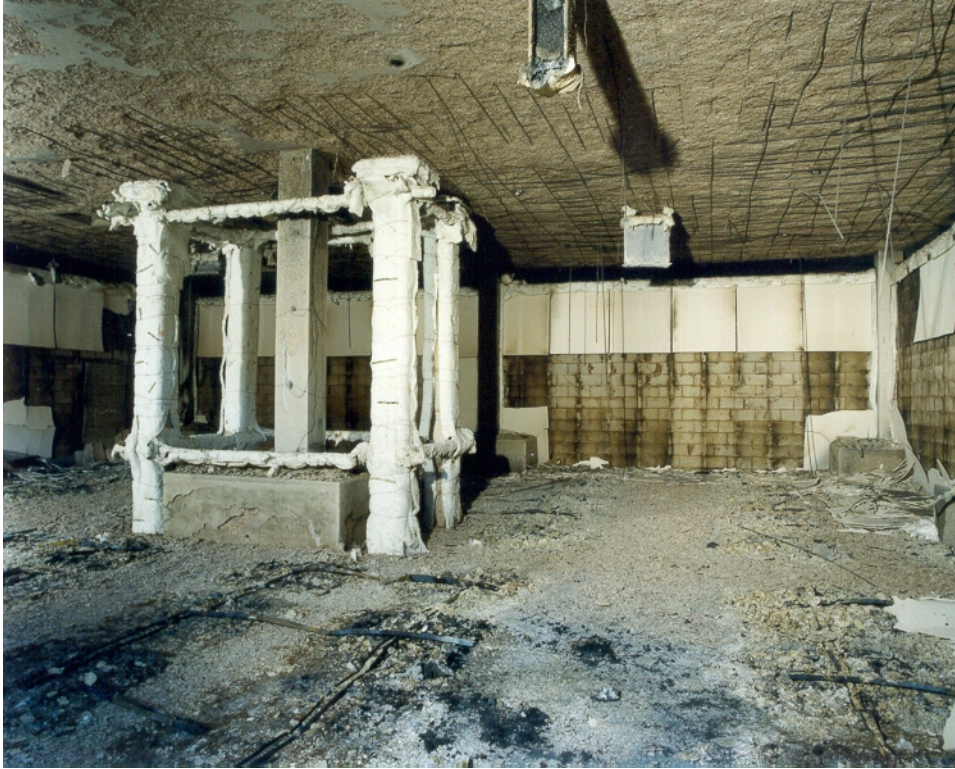
Figure 17 Picture looking into compartment from column D2 showing extent of spalling.

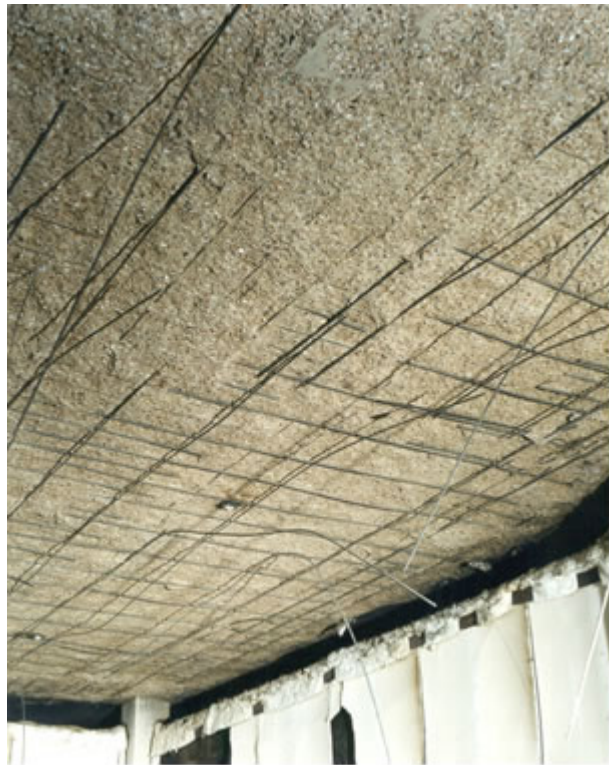
Figure 18 Picture showing spalling (looking at column B2)

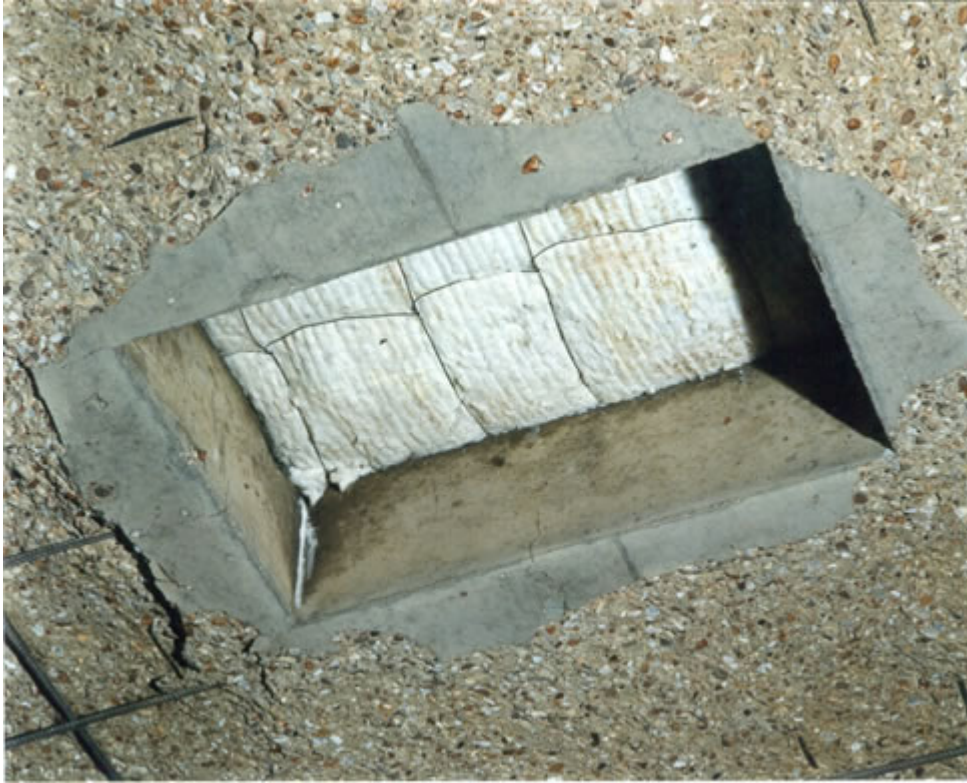
Figure 19 Picture showing spalling around service hole

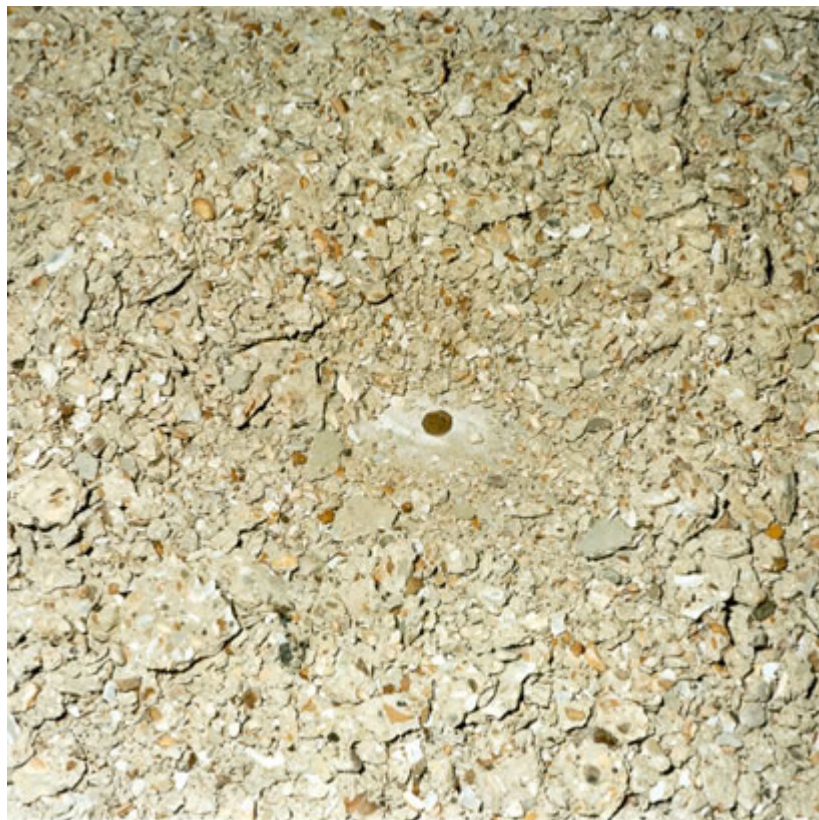
The debris from the spalling on the floor of the compartment (Figure 20) was 90mm deep at the worst location. This debris clearly reduced the severity of the fire, as observed during the test.

Figure 20 Picture showing extent of spalling (debris) on compartment floor
(50 pence shown for scale)

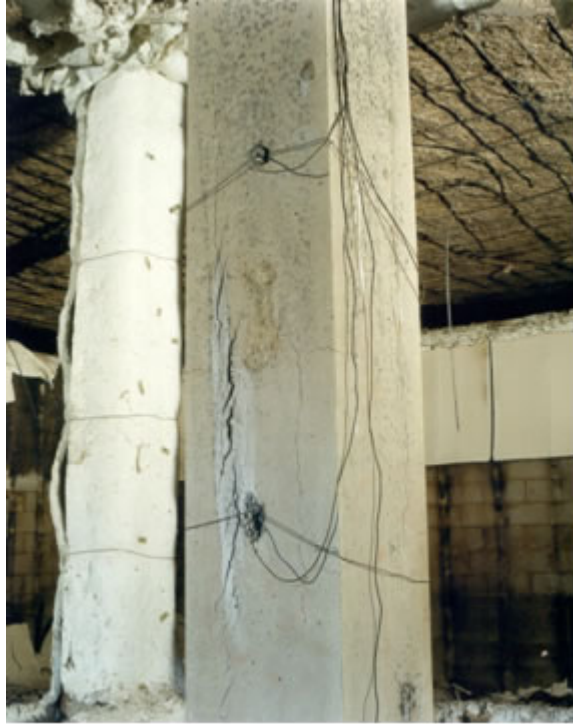
Inspection of the columns after the test showed that longitudinal cracks, approximately 50mm into the column had formed (Figure 21). It was relatively easy to remove the outer concrete as shown in Figure 22. The behaviour of the column shown in Figures 21 and 22 is typical of corner spalling.

Figure 21 Longitudinal cracks in Column C3.

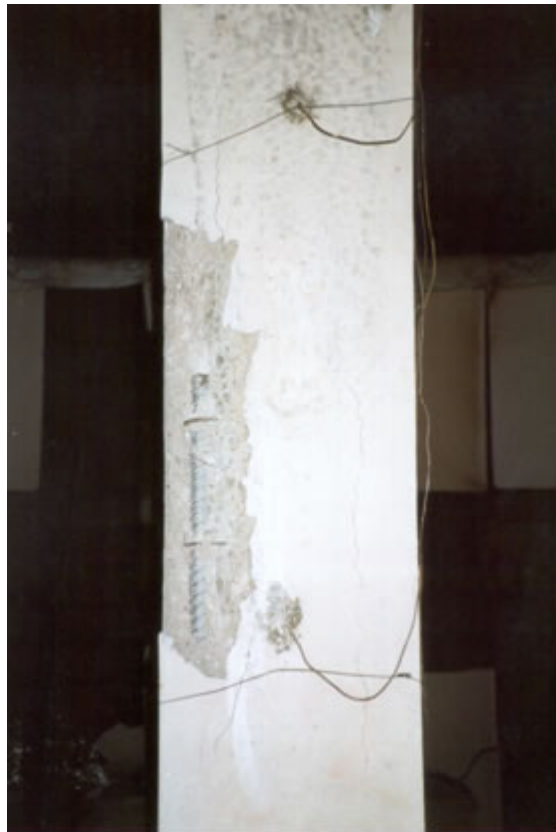
Figure 22 Removal of outer (corner) concrete on column C3
