# **Precast Concrete Hollow Core Slabs in Fire**

**By Tom Lennon, Principal Consultant, BRE**

## **Synopsis**

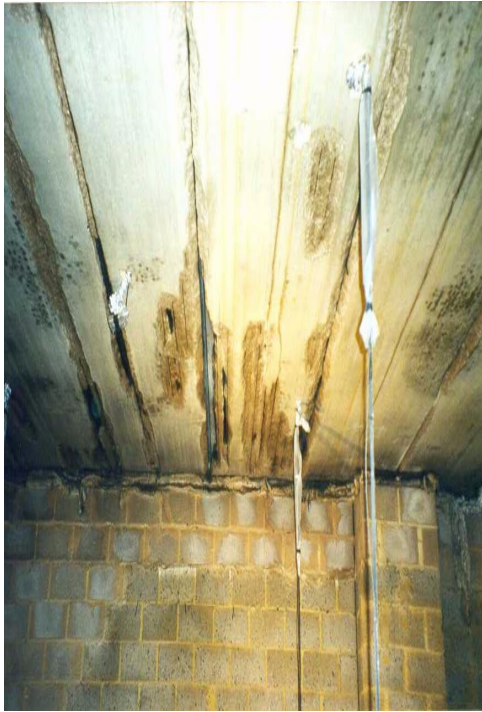
Figure 1 Spalling

The issue of spalling arose following a fire test carried out at Cardington in support of the European Natural Fire Safety Concept in February 1999. The slabs supplied had two hours fire resistance. It was anticipated that the slabs would remain intact for several tests before replacement was necessary particularly as they were only there to form the ceiling to the fire compartment and were not subject to any applied load. The first test had to be terminated 40 minutes after ignition due to the extensive cracking of the slab. Spalling began approximately twenty minutes from ignition with large lumps of concrete being removed in an explosive manner. This continued to the point where the reinforcement was completely exposed on the majority of the units and cracking had extended the full length of the 6m span. The damage to the underside of the units is shown in figures 1 (general view of underside of floor slab) and 2 (close up showing exposed reinforcement). The explanation for the damage was that the units had not been properly conditioned or stored and that consequently the moisture content was too high at the time of the fire test. One of the important objectives was to see if this behaviour could be replicated where the history of the precast units was known.

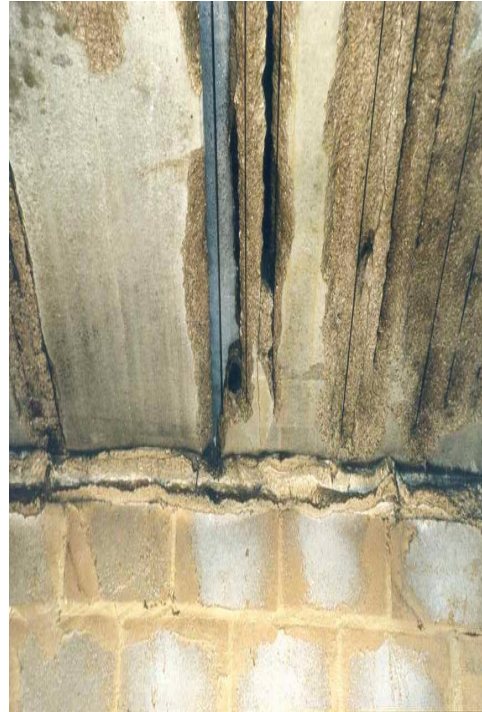
Figure 2 exposed reinforcement

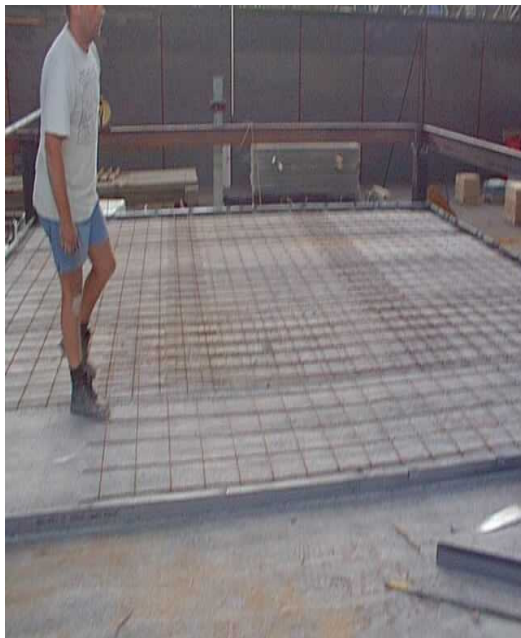
Figure 3 A98 mesh

Slab A – all joints filled. Structural topping consisting of 50mm (minimum) depth of concrete and a mesh reinforcement (A98 mesh with 300mm lap between sheets) – see figures 3 to 5.

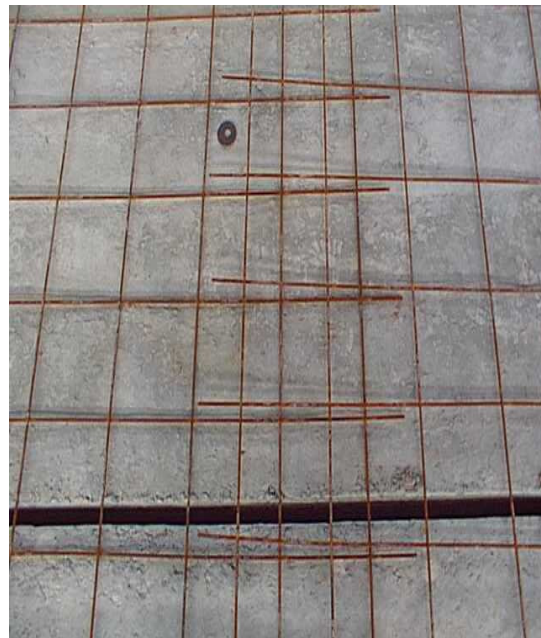
Figure 4 overlap of mesh

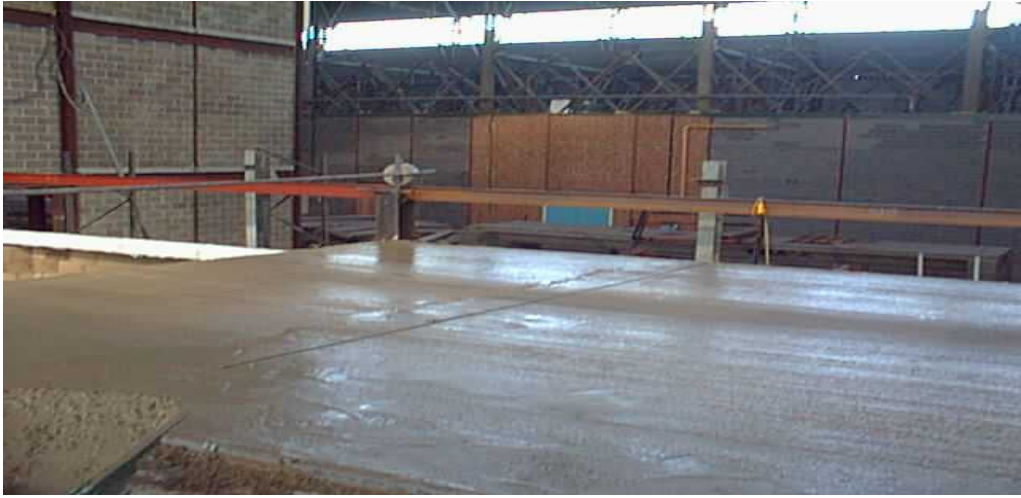
Figure 5 structural topping – slab A

For slab A the structural topping was 50mm thick at midspan. The concrete grade was specified as a minimum design strength of 25N/mm<sup>2</sup> with a maximum aggregate size of 10mm. A pump mix was specified to facilitate placing the concrete. The measured compressive strength of the 3 test cubes at 28 days was 42.5, 43 and 43.5N/mm<sup>2</sup>.

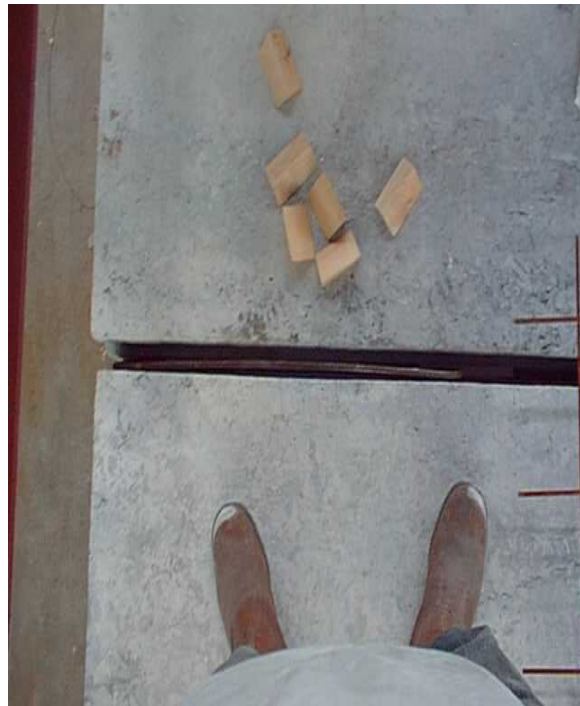
Figure 6 hooked bar over edge beam

Slab B – all joints filled and hooked reinforcing bars placed in the joints over the supports – see figures 6 and 7.

For slab B the hooked bars sat in the joints between the units to give top cover and cover between the end of the slab and the bar of 25mm. Over the central beam the bars had an overall length of 500mm. Over the front edge beam the length was 775mm to allow for the overlap at the front.

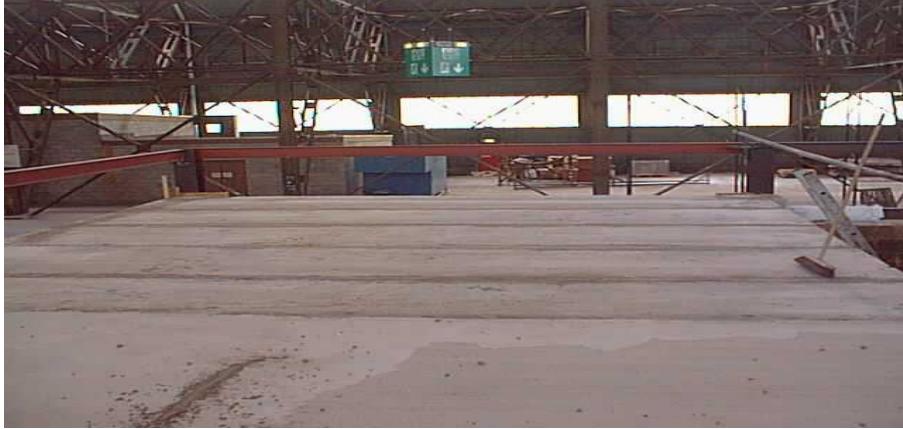
Figure 7 joints filled – slab B

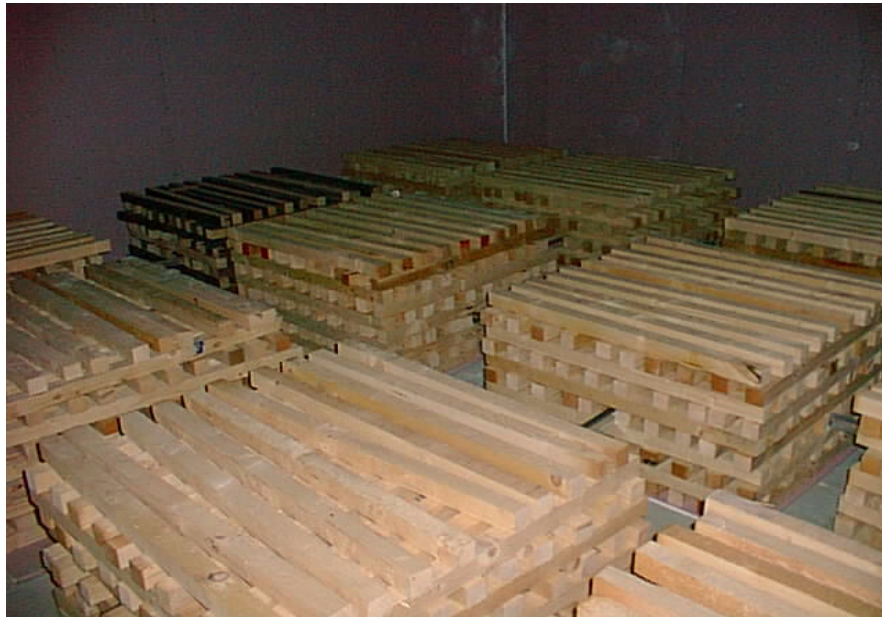
Figure 8 Crib Layout

The design fire load is based on a value of  $570\text{MJ/m}^2$  consisting of  $30\text{kg}$  of wood per square metre of compartment floor area multiplied by a calorific value for wood of  $19\text{MJ/kg}$ . This is a typical design value and is based on the design fire calculation in the most recent version of the fire part of the Eurocode for Actions<sup>(4)</sup> assuming normal fire detection measures are present. The layout of the cribs on the floor of the compartment is shown in figure 8.

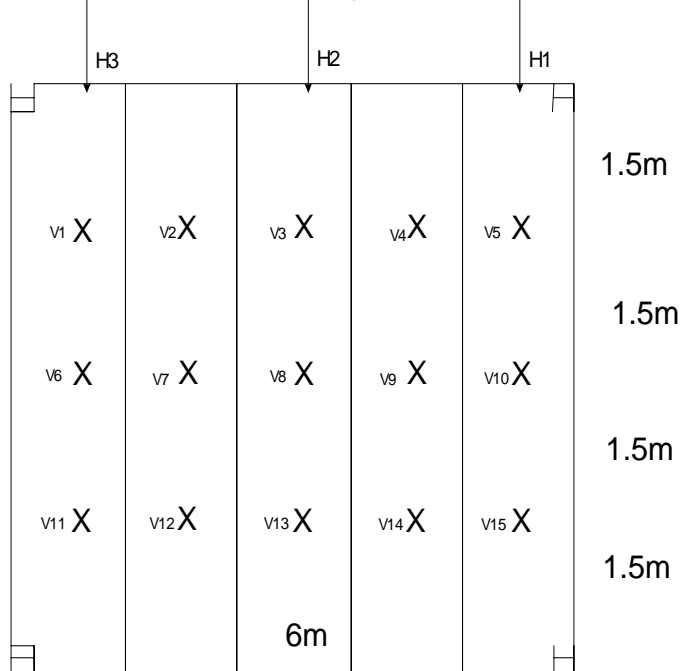
Slabs supported on flange of central beam

Front opening slabs supported on  
RSJ lintel spanning between piers

Figure 9 Location of displacement measurements

Figure 9 shows the location of the vertical and horizontal displacement transducers. Figure 10 shows the location of the thermocouples used to measure compartment gas temperatures.

The measurement positions for horizontal displacement are as indicated in figure 9. During the test flames and hot gases were seen to emerge from the rear of the compartment. This would have caused some extension of the cables attached to the transducers. The residual readings the next morning were 1.75mm, 3.03mm and 4.69mm for locations H1, H2 and H3 respectively. In this case a positive reading indicates movement away from the fire compartment. It was not possible to take readings at the front of the compartment because of the flames and hot gases emerging from the opening.

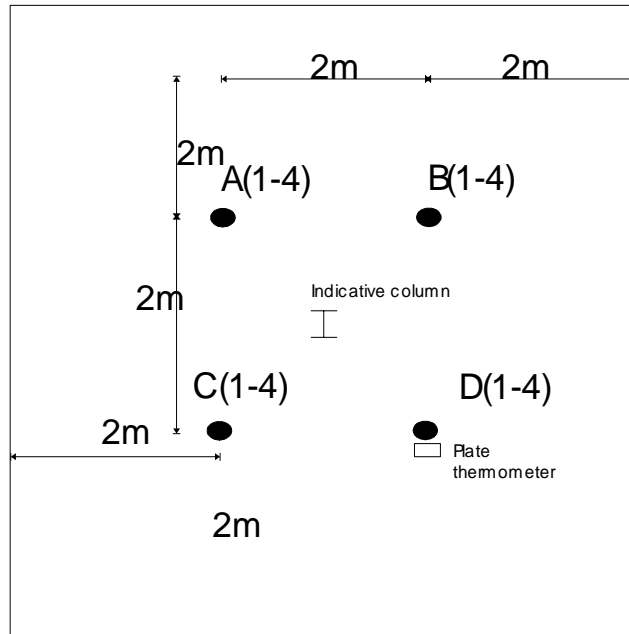
Figure 10 location of temperature measurements

The location of the thermocouples used to measure the atmosphere temperature within the compartment is shown in figure 10. Figure 11 shows the temperature of each thermocouple for the duration of the fire test. Two things are immediately clear from looking at these figures: firstly the fire was very severe in terms of peak temperatures and secondly the temperature within the compartment was uniform. The average value shown in figure 12 is therefore a reasonable approximation of the thermal exposure throughout the compartment. Figure 12 also includes the standard furnace time-temperature profile for comparison.

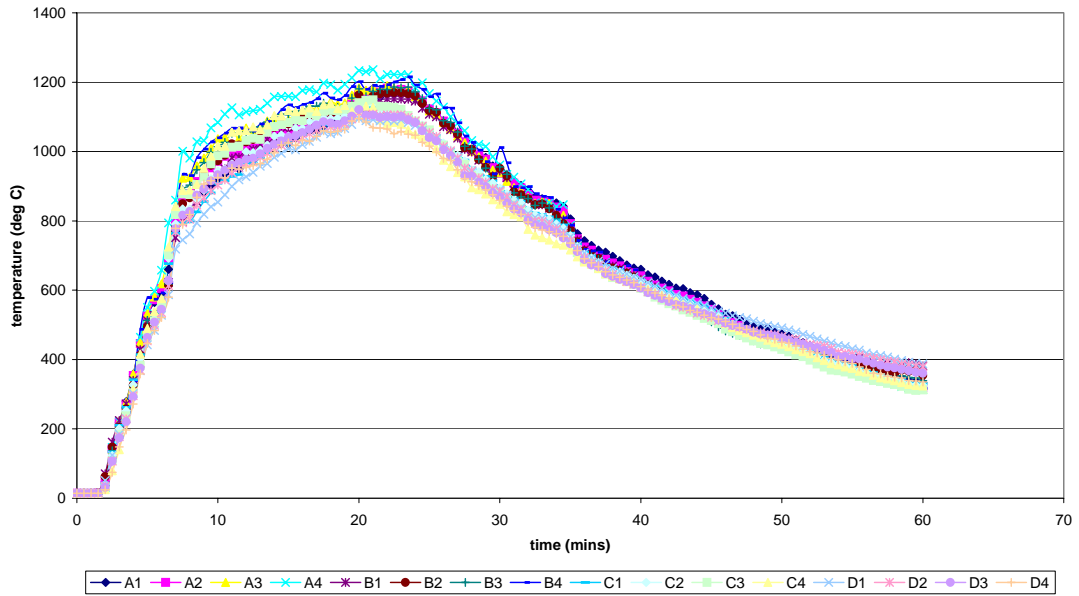
Figure 11 Atmosphere temperatures – slab A

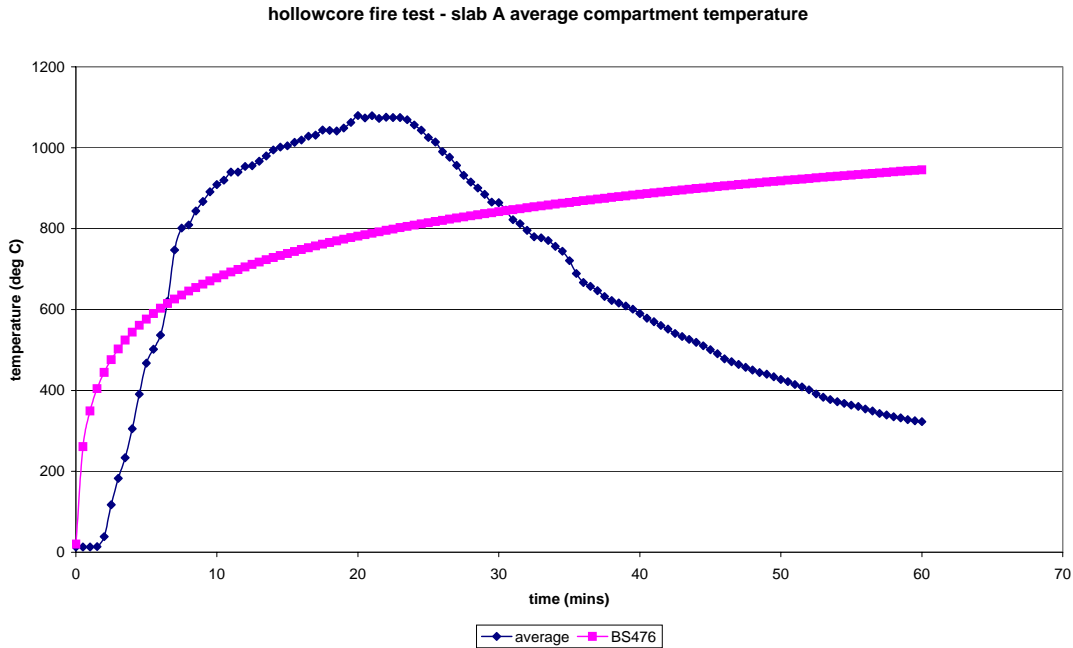
Figure 12 Average atmosphere temperature – slab A

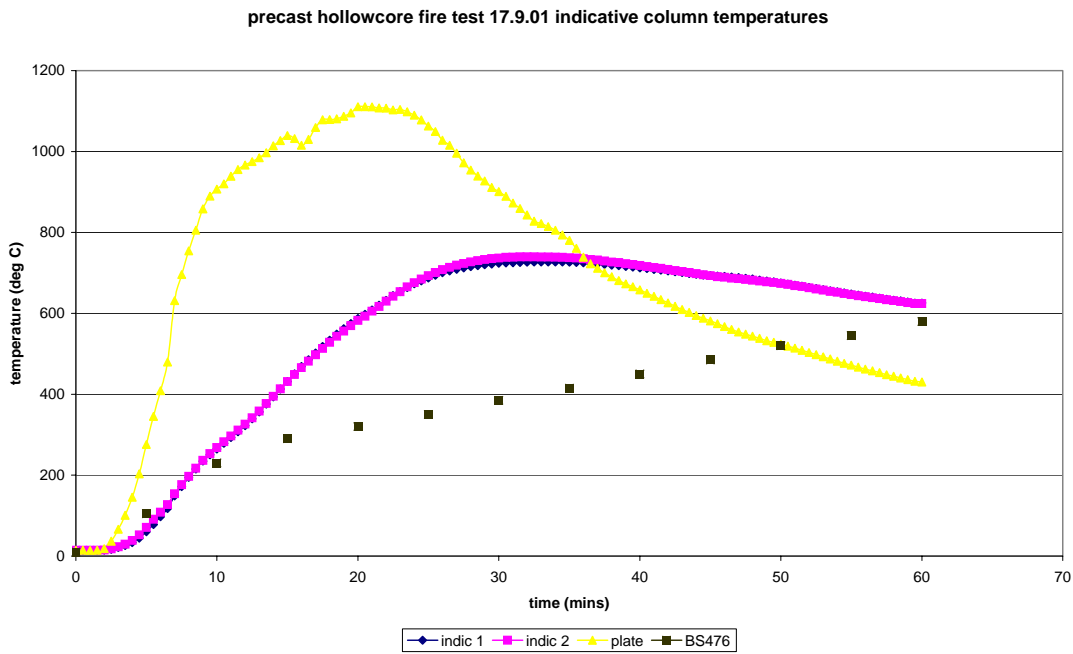
Figure 13 Comparison of indicative column temperatures from fire test and standard test

Two methods were used in an attempt to provide a more comprehensive picture of the thermal environment within the fire compartment. Indicative test specimens sprayed with an intumescent coating were used to derive time equivalent values for the test and, in the light of the changes to standard test procedures a plate thermometer was located in the compartment close to one of the standard thermocouples used to measure the atmosphere temperature. The indicative temperatures from the test are plotted alongside approximate values taken from a BS476 test in figure 13. The results indicate a time equivalent value of well in excess of 60 minutes for the test fire.

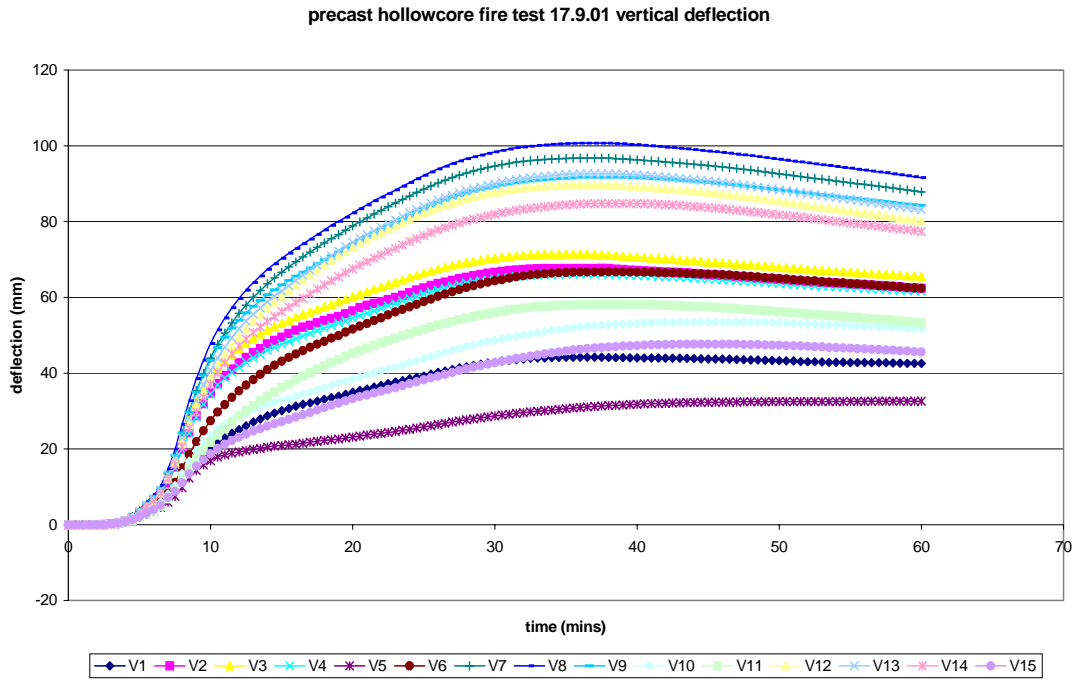
Figure 14 Measured values of vertical deflection

Figure 14 shows the measured value of vertical deflection at all measurement positions. Not surprisingly the maximum deflection occurred in the centre of the central unit. The maximum displacement recorded during the test was 100mm. Figure 15 shows the central deflection plotted against average atmosphere temperatures. The figure clearly shows the heat sink effect of the concrete slab with the deflection continuing to increase as the

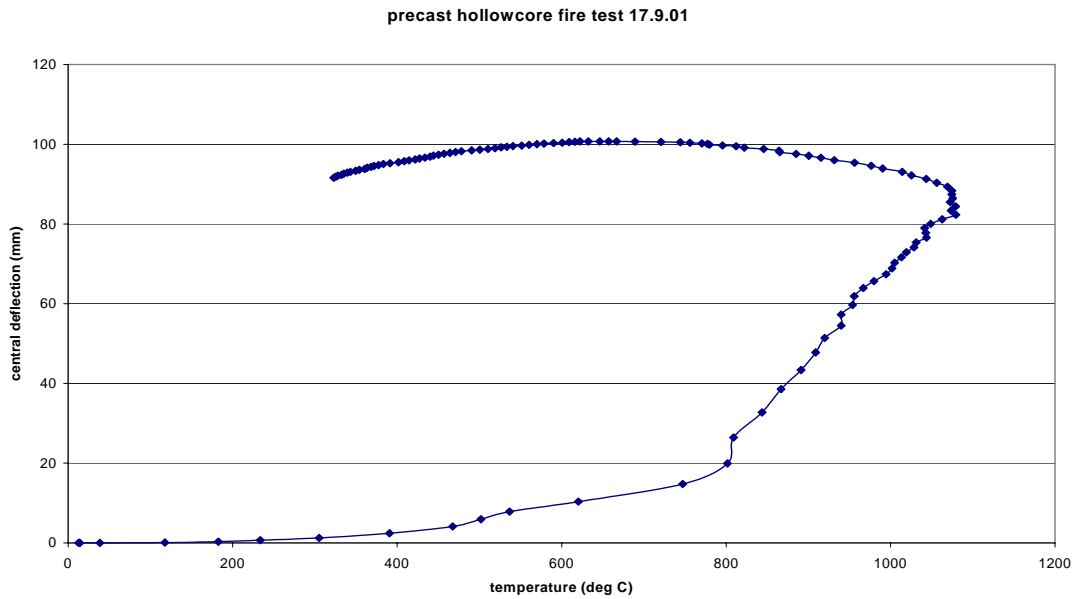
Figure 15 central deflection against temperature

atmosphere temperature reduces. Readings were taken overnight and the central deflection recovered to a residual displacement of 32mm by the following morning.

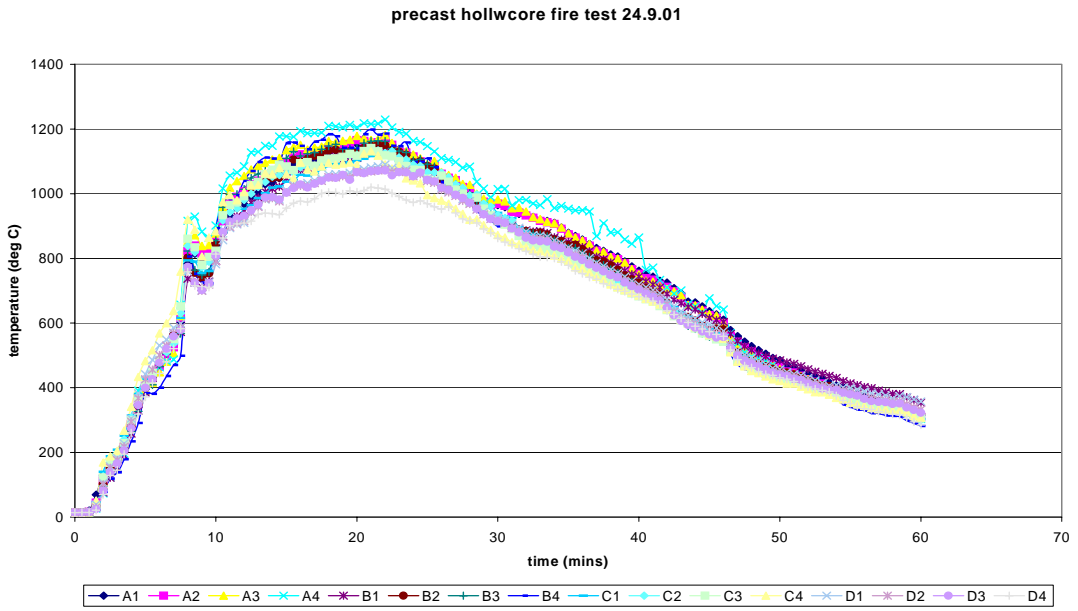
Figure 16 Atmosphere temperatures – slab B

The instrumentation locations were the same as those used in the first test. Figure 16 shows the measured temperature values from all the thermocouples used. Again the fire temperatures are relatively uniform justifying the use of average values for subsequent comparison and analysis. Figure 17 shows a comparison between the average values for tests 1 and 2. It can be seen that test 2 is slightly more severe in terms of maximum temperature and duration. This may have been due to the fact that, in the second test, the plasterboard linings stayed intact for longer and the gap between the two adjacent compartments remained closed for a longer period. Small differences in the moisture content of the timber may also have had a contribution. However, the two tests are comparable in terms of overall severity.

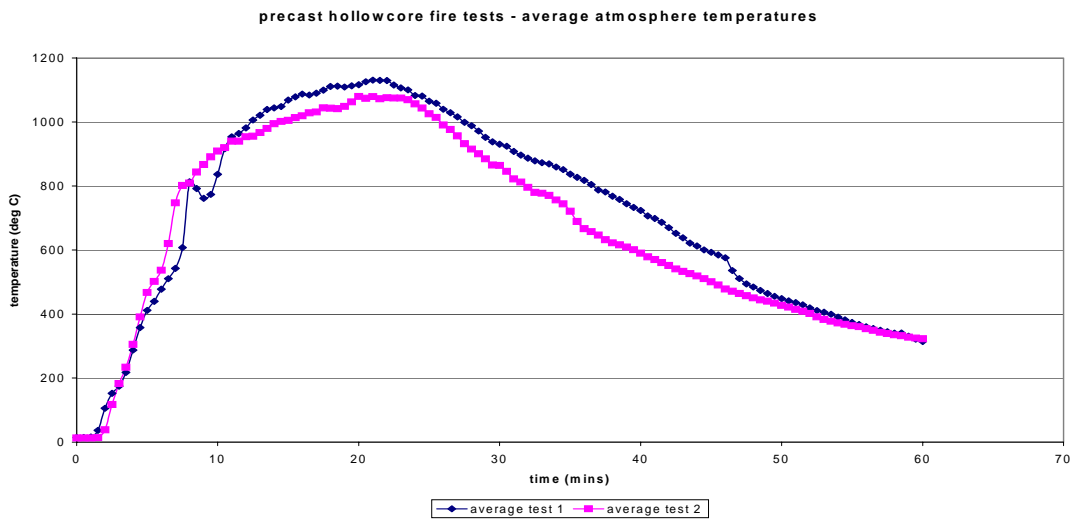
Figure 17 Average atmosphere temperature – Slabs A and B

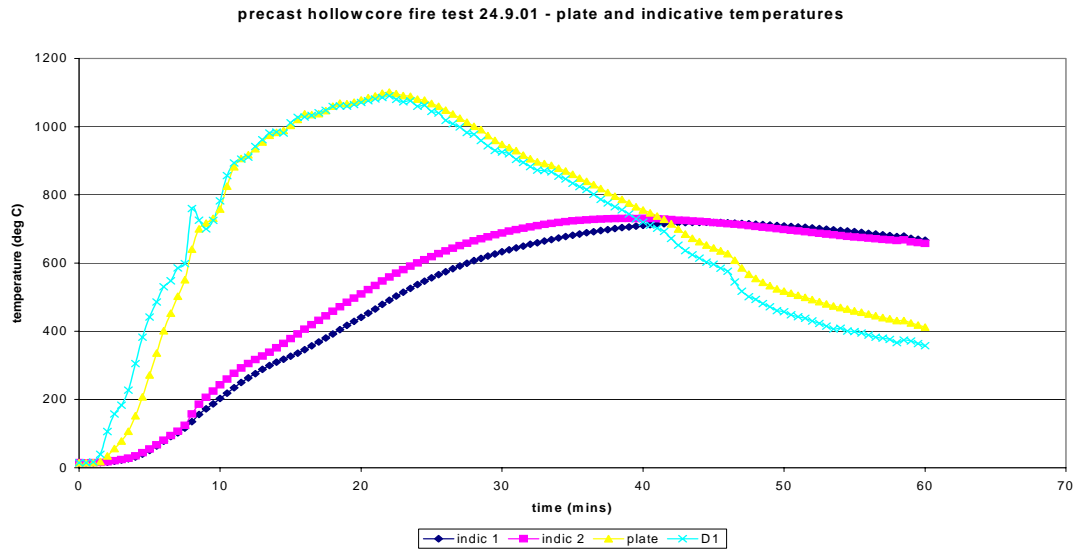
Figure 18 Plate and indicative temperatures – Slab B

Figure 18 shows the plate thermometer reading together with the indicative column temperatures. There is some uncertainty about the thickness of the intumescent coating for this test so there are no comparable BS476 results.

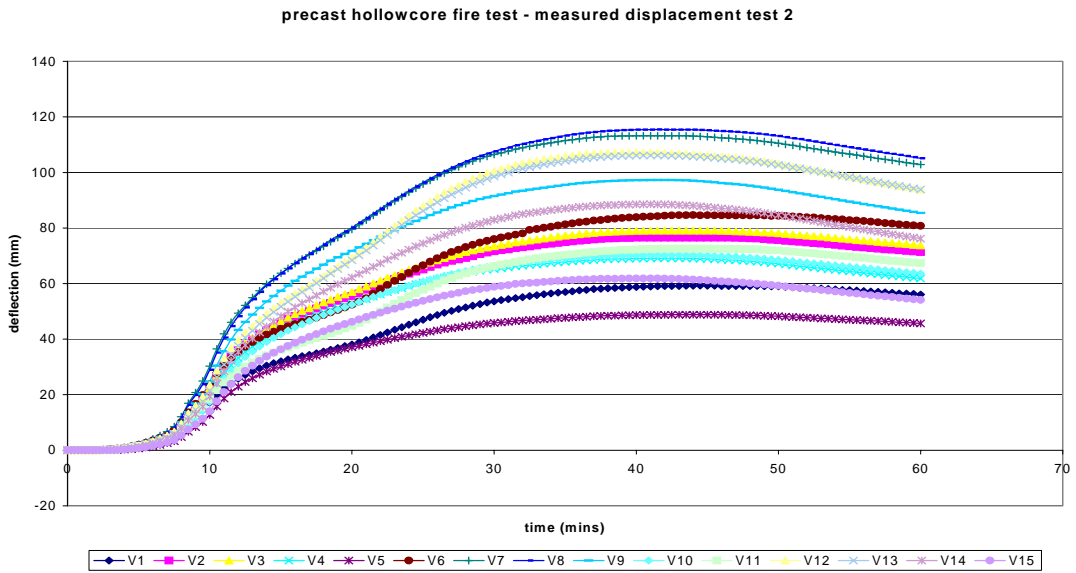
Figure 19 Measured vertical displacement – slab B

The measured values of vertical deflection are shown in figure 19. The maximum measured deflection (centre of the slab) is shown in figure 20 and compared to that for test 1. The greater displacement associated with the second test is due to two factors: the absence of a structural topping over the pre-cast units, and the increased severity of the fire. Of these the absence of a restraining force from the topping is the most important. The maximum deflection for test 2 was 115mm compared to 100mm for test 1. The residual displacement for test 2 was 40mm.

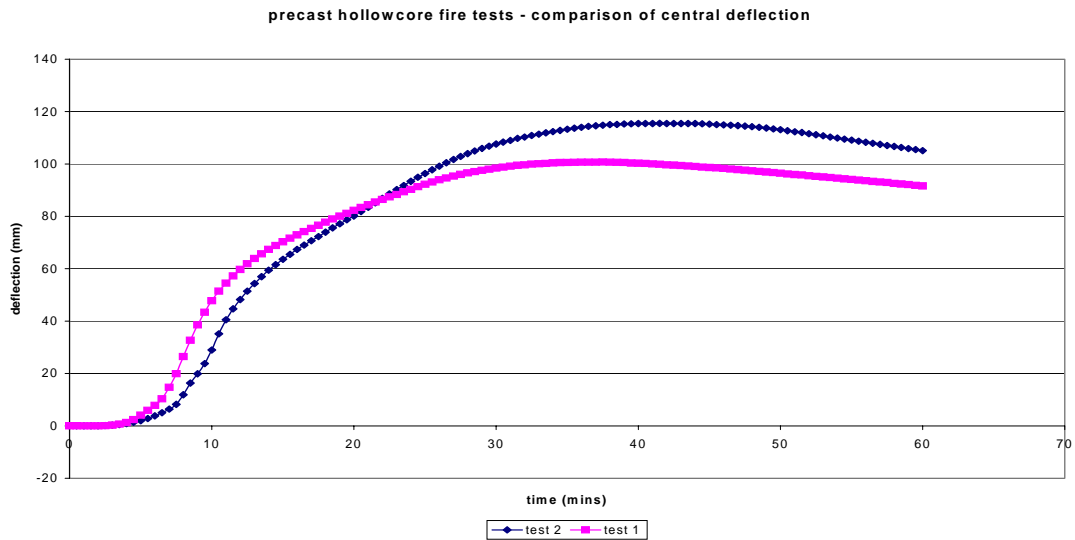
Figure 20 Comparison of central deflection – Slabs A and B

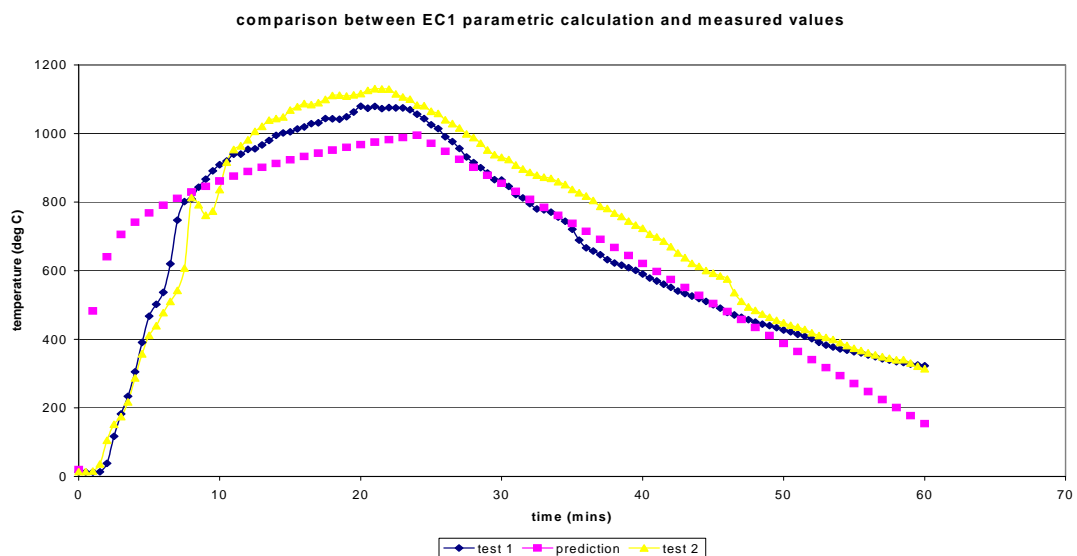
Figure 21 Comparison between Eurocode calculation and measured values

The predicted time-temperature response for the design fire scenario is shown in figure 21. The imposed load on each of the floor slabs was 3.66kN/m<sup>2</sup>. This load was applied through 12 1.1tonne sandbags spread uniformly over the floor area of approximately 36m<sup>2</sup> and corresponds to a realistic value for the fire limit state.

The two tests described in this report provided further evidence to assess the calculation procedure for compartment temperature presented in Annex A of the latest version of the fire part of EC1. Figure 21 is a comparison between the predicted temperature based on the parameters described in the section, fire design scenario, and the measured values for the two tests. The calculated thermal exposure is very close to the measured values both in terms of maximum temperature and overall duration. The parametric approach would be appropriate for compartments with similar parameters in terms of fire load, insulation characteristics and opening factor.

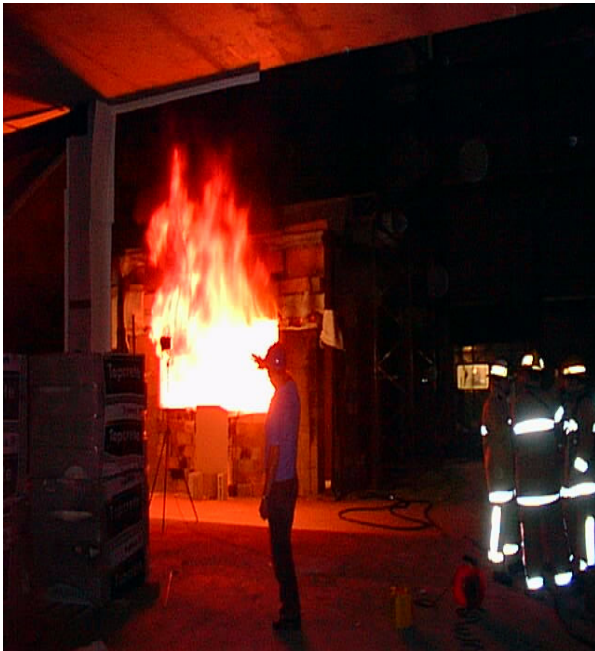
Figure 22 Slab A Post-flashover fire

Figures 22 and 23 show the front of the compartment for each test following flashover. The length of the flame plume leaving the opening gives some indication of the intensity of the fires. Figure 24 shows the underside of the hollowcore units following test 2. In the first test localised surface spalling occurred. However, this had no effect on the ability of the units to sustain the applied load and would require only surface filling to reinstate the original appearance. Although there was no evidence of spalling in test 2 there was some cracking along the length of one of the edge units. Throughout the tests and for many months afterwards the slabs continued to support the applied load without any sign of distress.

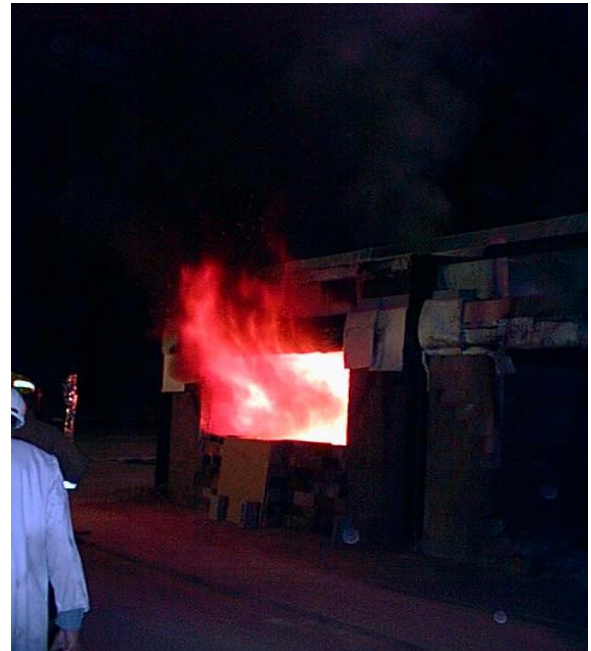
Figure 23 Slab B post-flashover

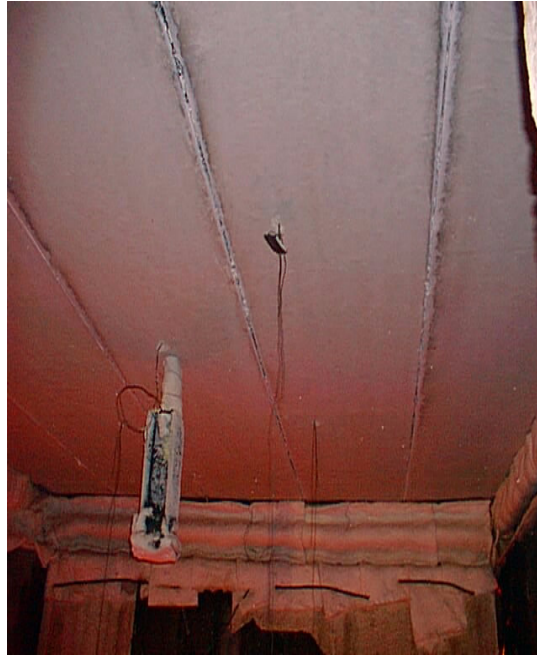
Figure 24 Underside of slab B post-test
